Dam ID: HI-00012
Kapaia Reservoir

Inspection No: _____
Date: 3/20/2006

STATE OF HAWAII - DLNR
VISUAL DAM SAFETY INSPECTION SHEET

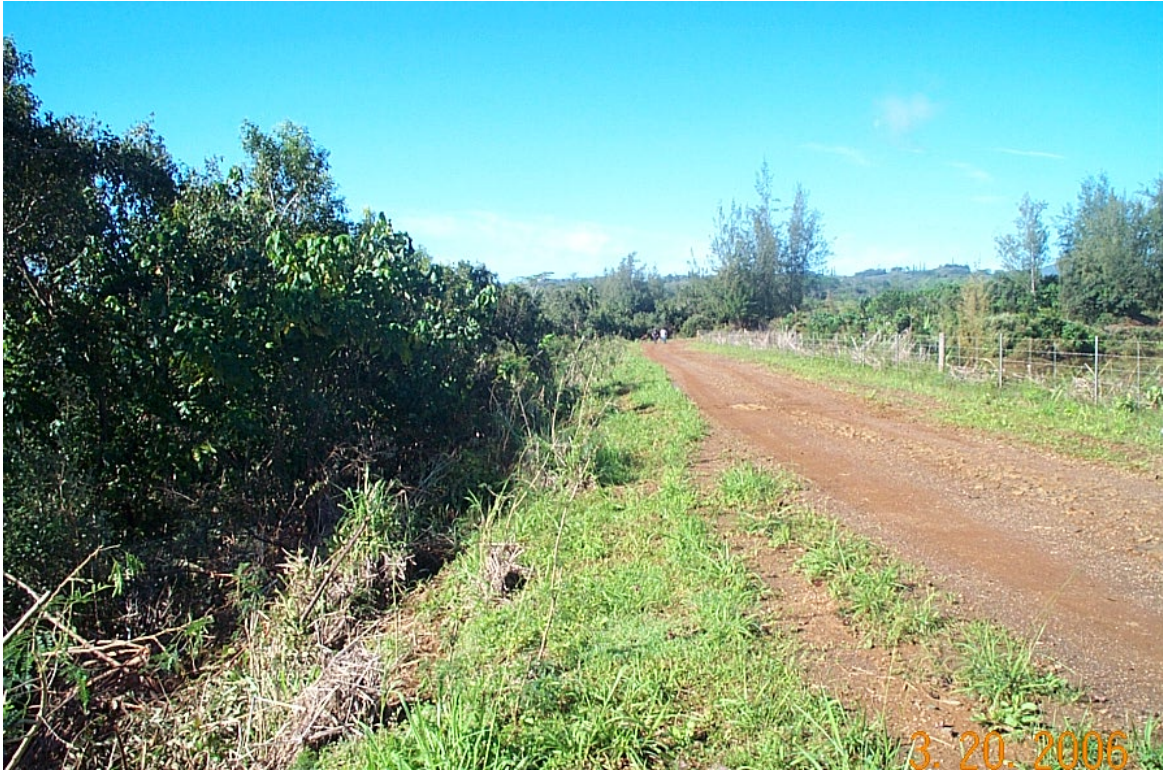
Vegetation: ☐ None ☐ Low Ground Cover ☒ Bushes or Tall Grass ☒ Trees # lots ☐ <6" ☒ >6" & <20" ☐ >20"Description: Too much vegetation; difficult to inspect; vegetation should be removed.Seepage: Seep Spot Number 1 Right Dam☐ Green Vegetation ☒ Wet or Muddy Ground ☐ Ponding Water ☐ Not Visible ☐ None Observed☐ Flowing, Description: Observed wet soil on downstream slope of the right dam above valley floor. The seepage was flowing out of boulders placed against the toe.Water Clarity: ☒ Clear ☐ Some particles ☐ Muddy ☐ Other: _____

HI00012 - Kapaia Reservoir: View of downstream slope and crest of the left dam. Note vegetation on downstream slope.

- ☐ h. A sinkhole was observed on the slope, which requires further investigation to determine the underlining cause. Repair and monitor the area.
- ☒ i. The down stream slope was very difficult to inspect due to high grass and bush vegetation. Clear high vegetation and maintain low to enable easy visual inspection.

- ☒ g. Tree(s) were observed on the downstream slope. Trees have been identified as the probably cause of piping failures, and can possibly cause sever damage to the embankment if they are uprooted during a high winds. Corrective action is required to remove the tree hazards from the dam. Acceptable remedies include removal of the tree and its root structure down to a 2" diameter and reconstructing the damaged embankment section. All repair work shall be accomplished as per the requirements of licensed geotechnical or structural engineer. Routinely monitor the damaged area for signs of settlement and seepage.

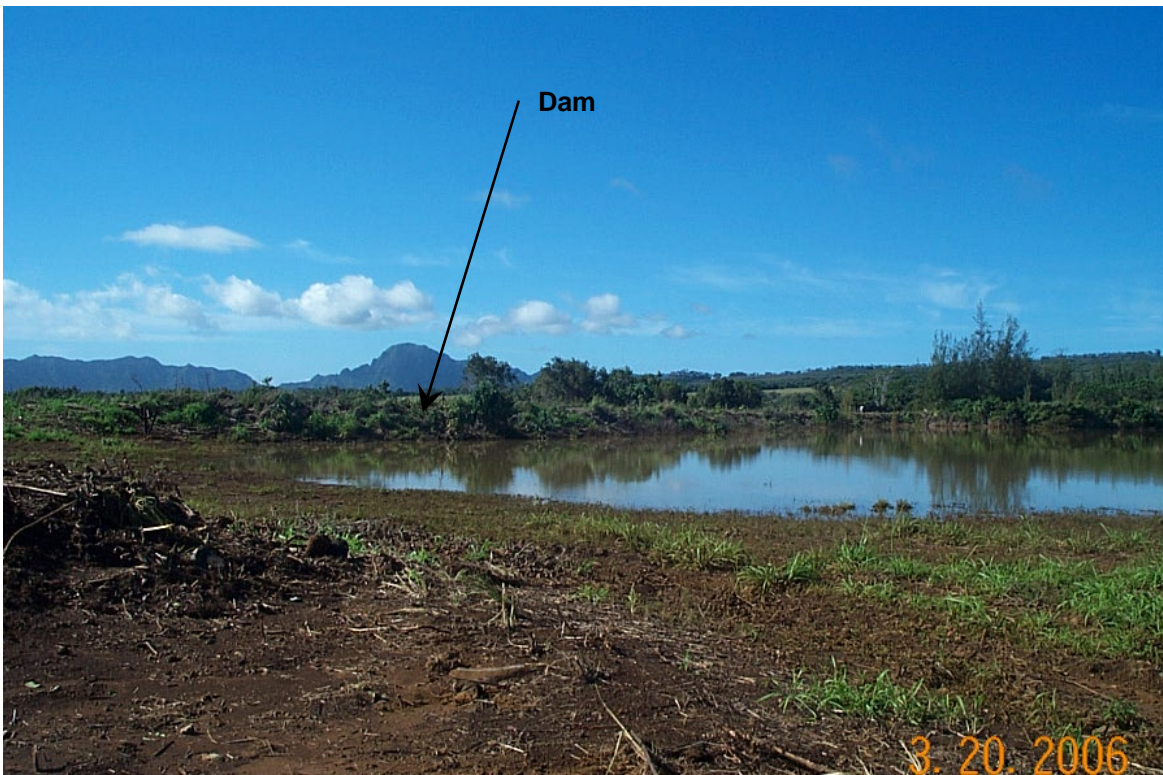
Vegetation: ☐ None ☐ Low Ground Cover ☒ Bushes or Tall Grass ☐ Trees # _____ ☐ <6" ☐ >6" & <20" ☐ >20"Description: Too much vegetation; difficult to inspect; clear vegetation.**Findings:**

HI00012 - Kapaia Reservoir: Upstream slope of dam of the left dam.

- ☐ h. A sinkhole was observed on the slope, which requires further investigation to determine the underlining cause. Repair and monitor the area.
- ☒ i. The upstream slope was difficult to inspect due to high grass and bush vegetation. Clear high vegetation and maintain low to enable easy visual inspection.

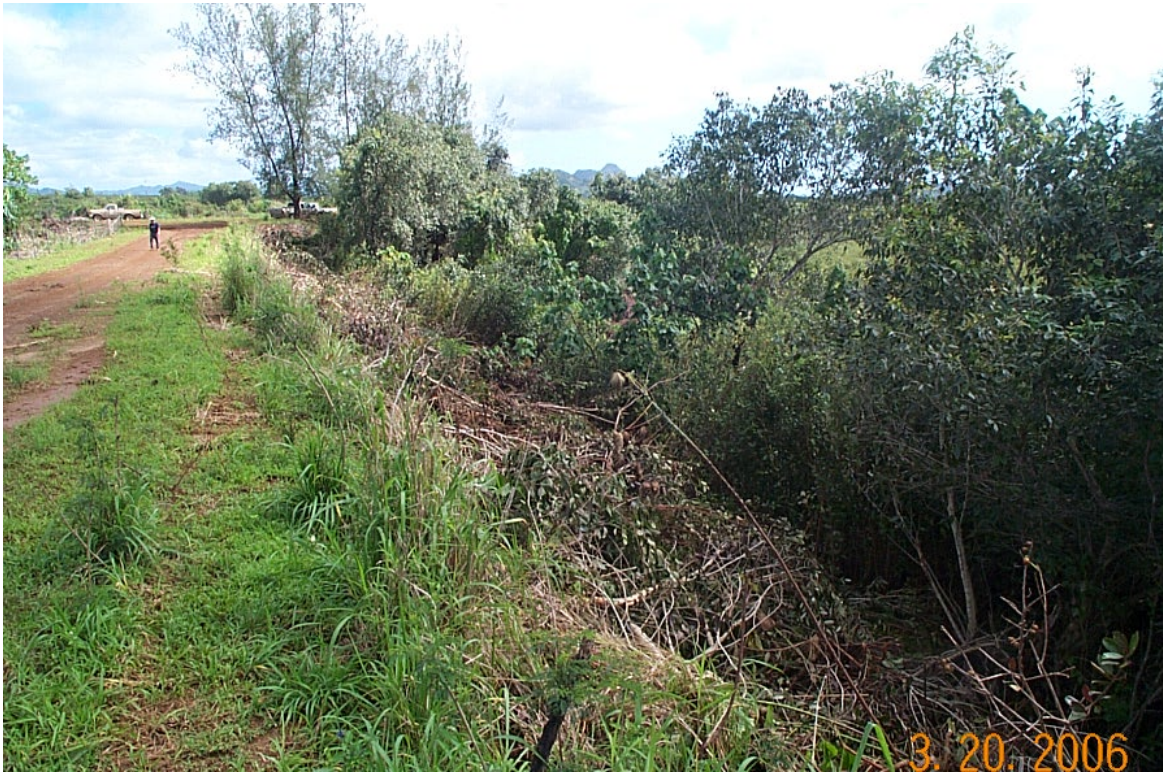
HI00012 - Kapaia Reservoir: Downstream slope of the left dam. Note dense vegetation on slope.

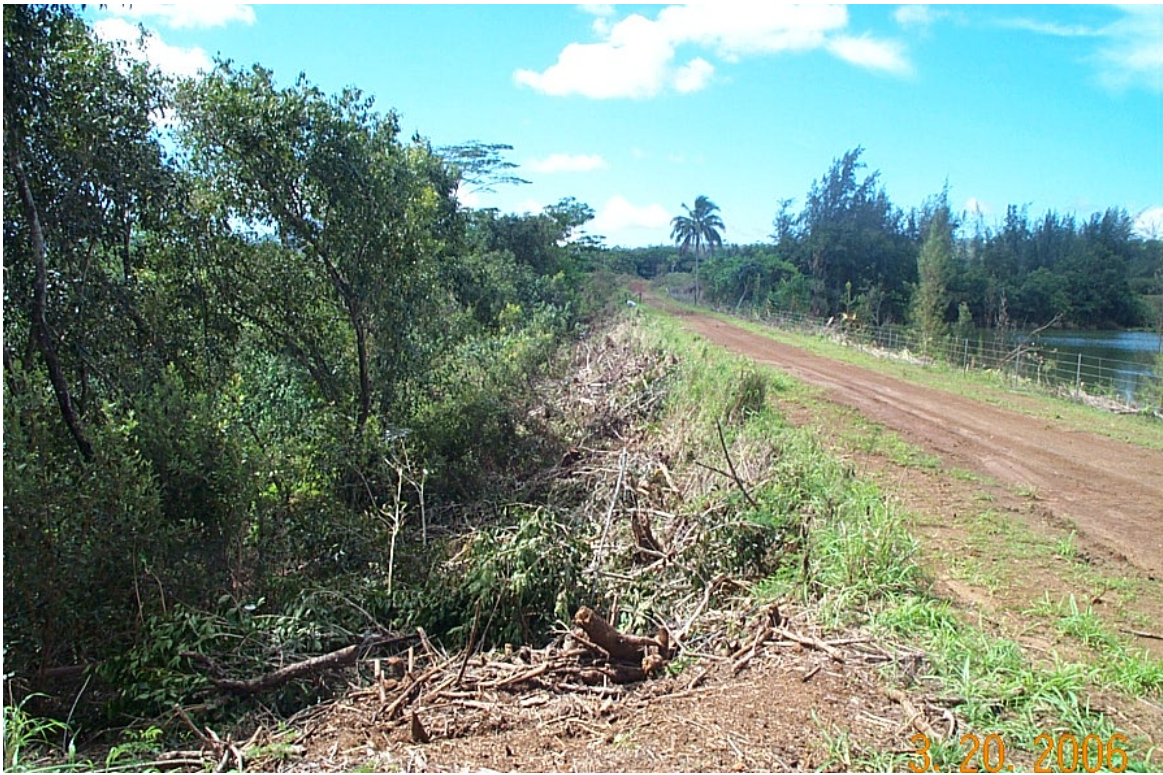
- ☒ h. Seepage/Ponding water was observed. Monitor and conduct further investigation to locate the source of water and extent of any possible hazardous or developing condition. Seepage on right dam above rock wall.

HI00012 - Kapaia Reservoir: Downstream slope of the right dam.
